**City of Miami
Marine Stadium
At
Virginia Key**

Existing Building Condition Assessment

Project No.: F008449.00

July 21st, 2008

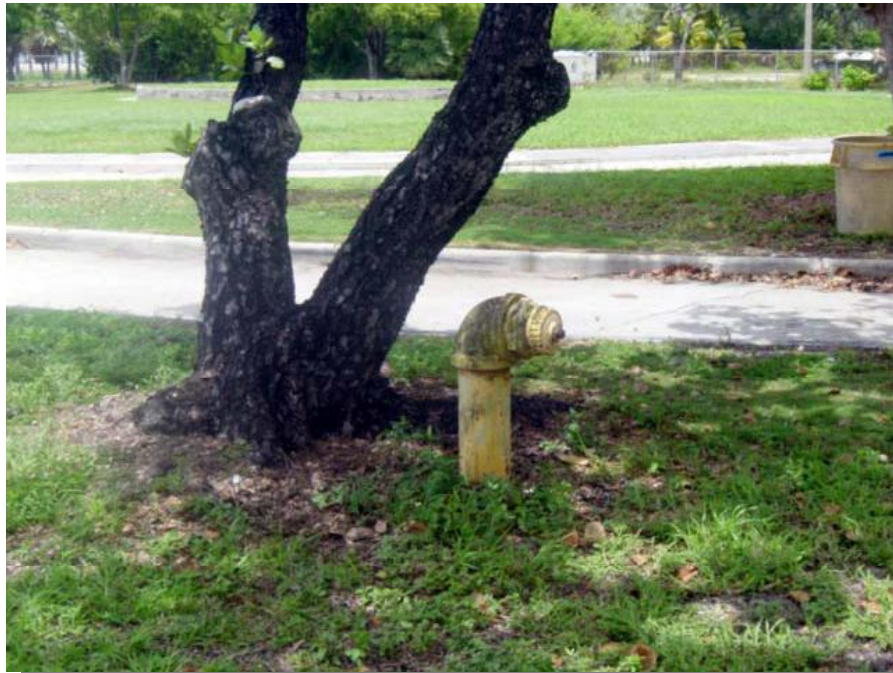
1- Fire Department Connection

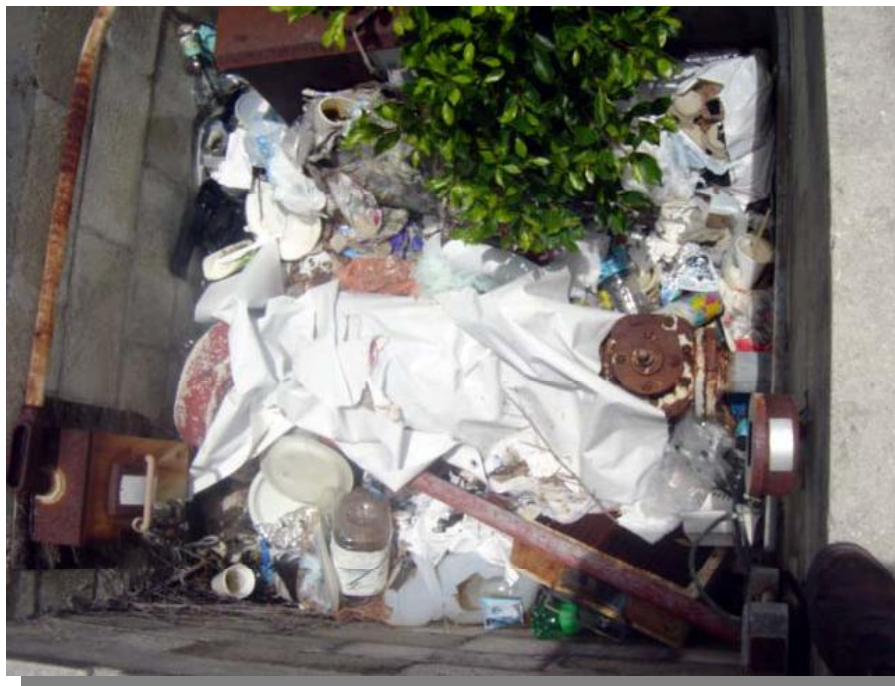
8- Water Service Enclosure

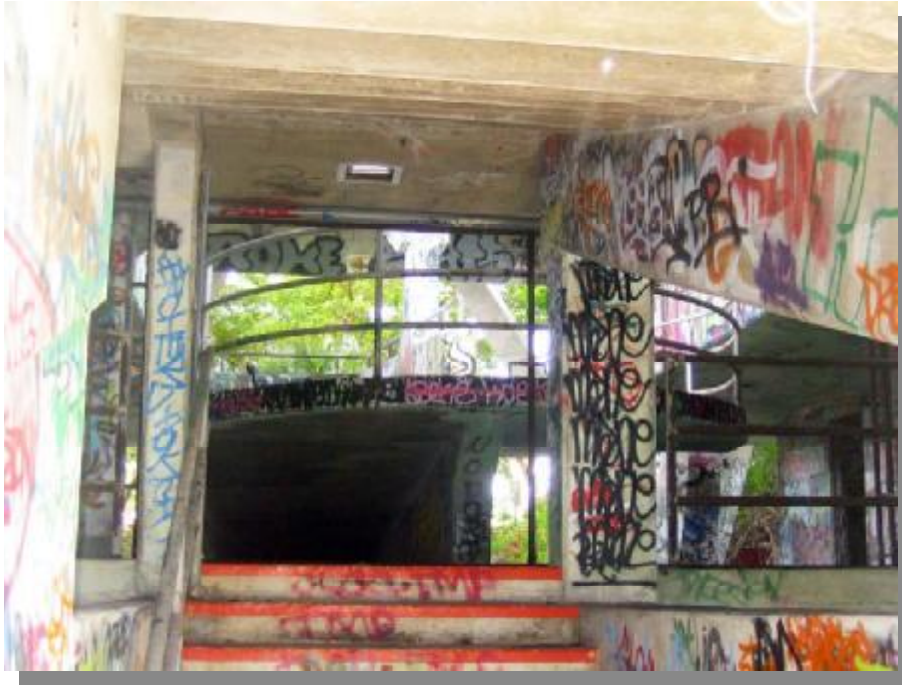
9- Ramp Area Egress with No Handicap Access

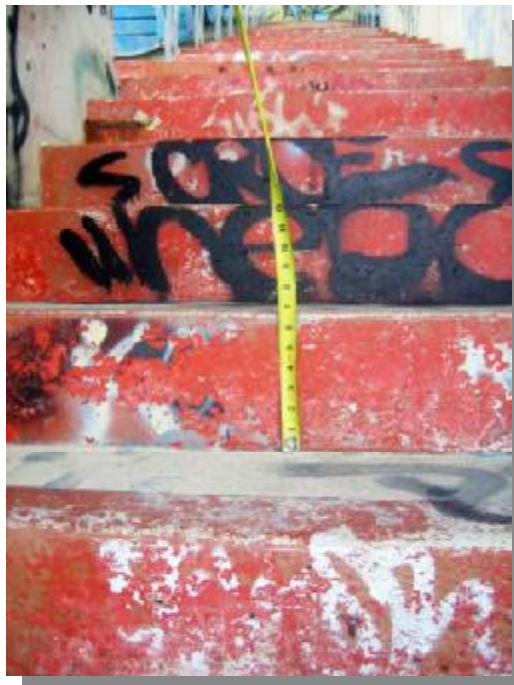
10- Stair Riser 7" High

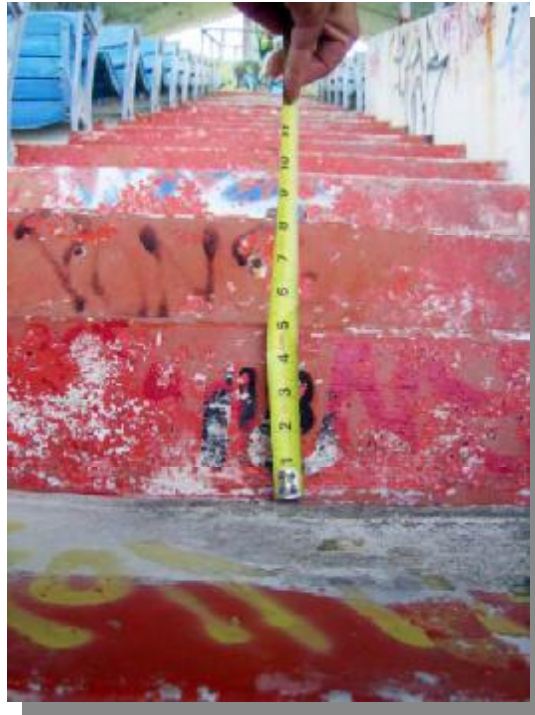
11- Stair Riser 5" High

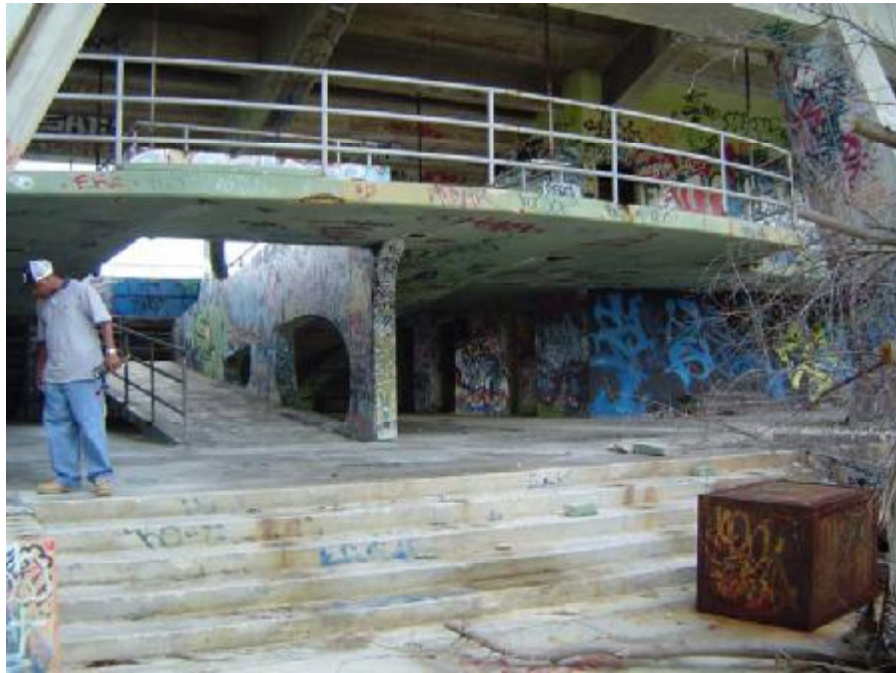
13- Typical Building Entry Access

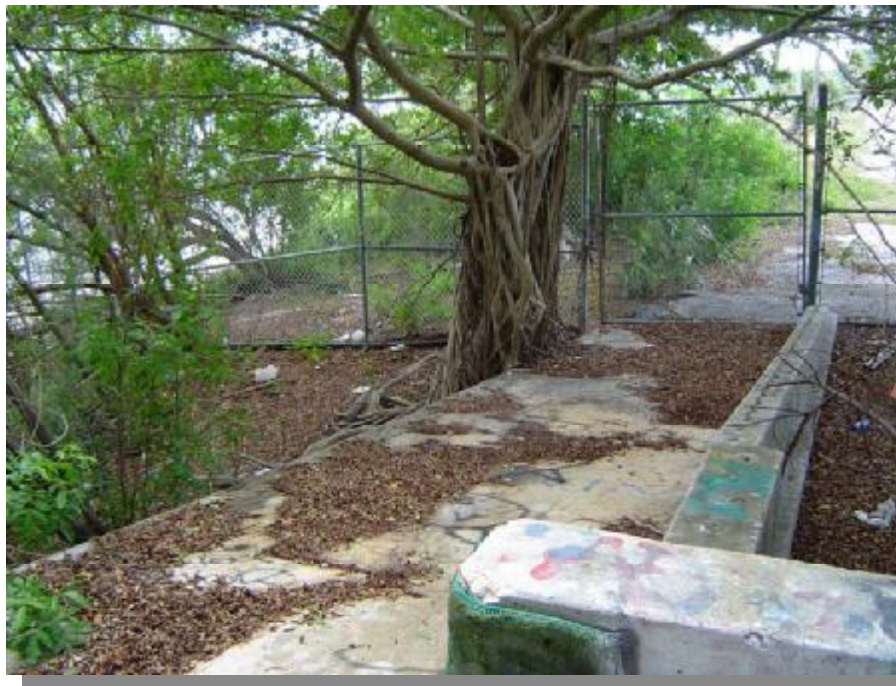
14- Ramp Access at Ground Level – No Guardrails and Handrails

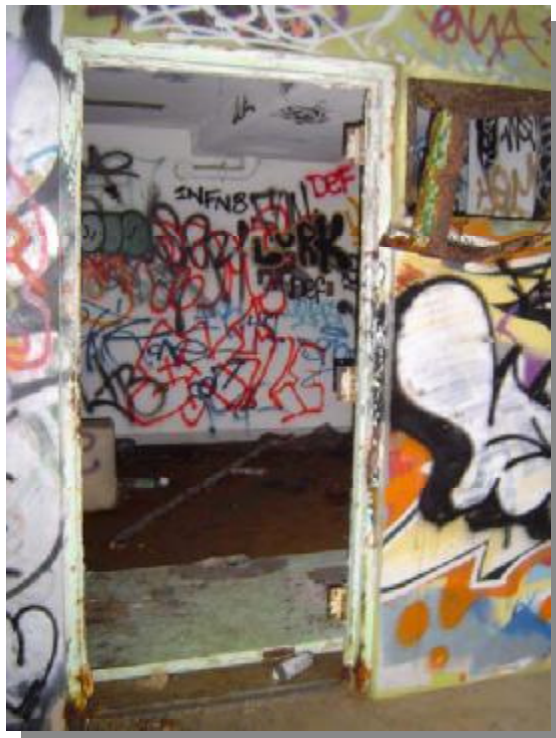
16- Typical Building Condition

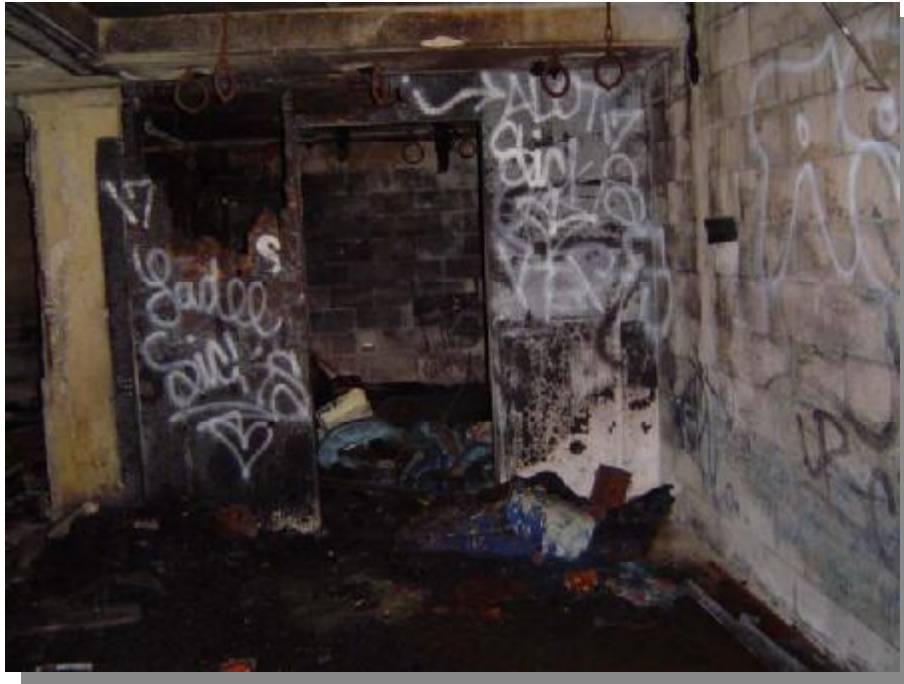
17- Typical Building Condition

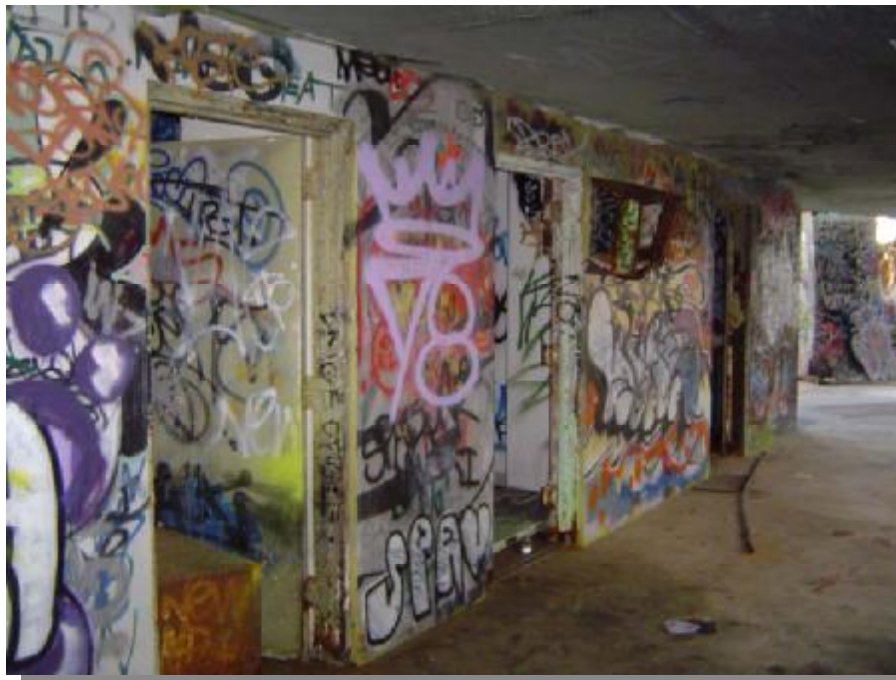
20- Typical Building Condition

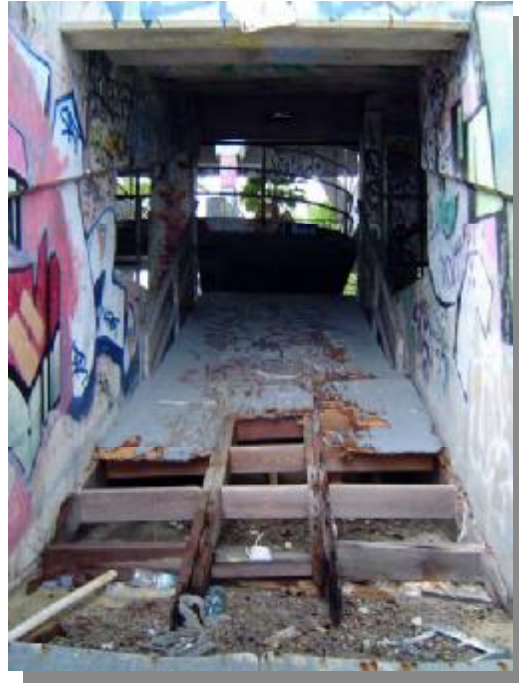
21- Ramp to Lower Level

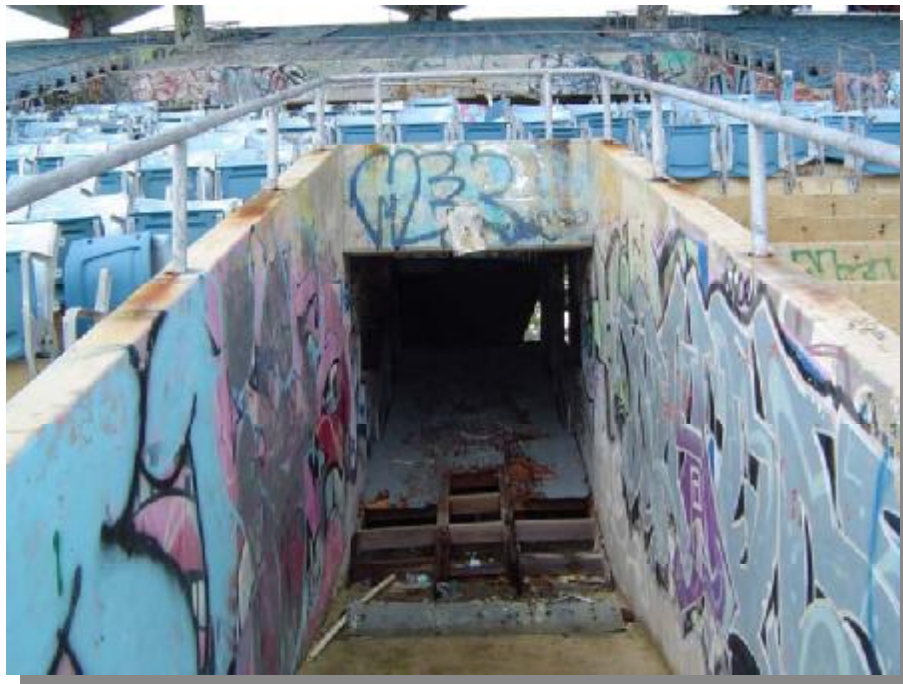
22- Ramp to Lower Level – No Guardrails and Handrails

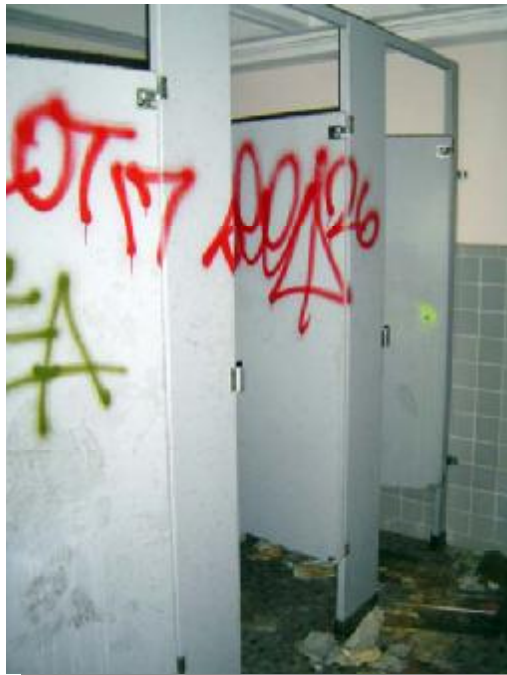
23- Rest Room Stalls, No Handicap Accessibility

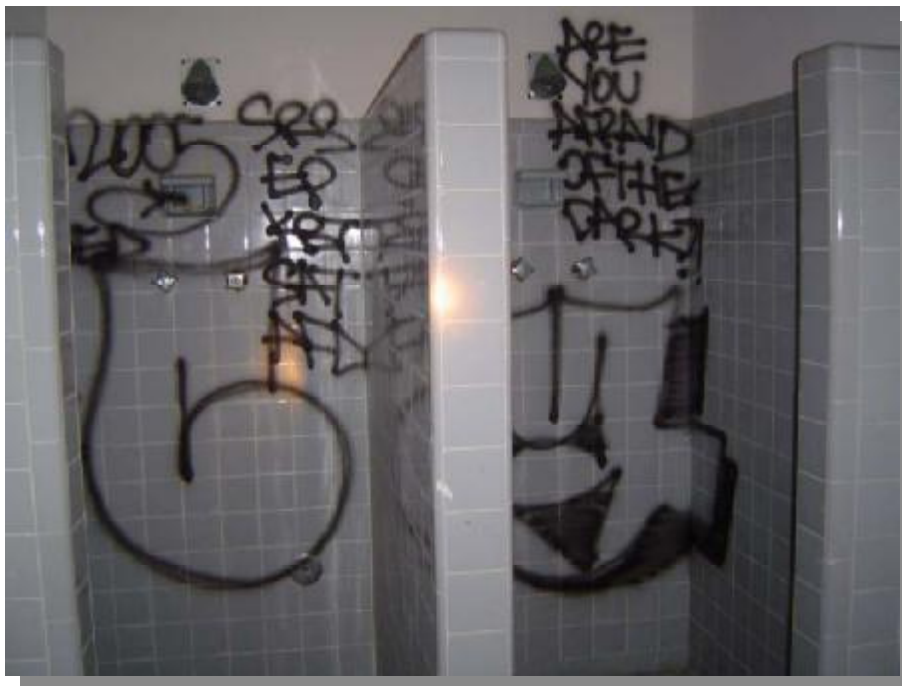
24- Tile with Possible Lead Content May Need to be Abated

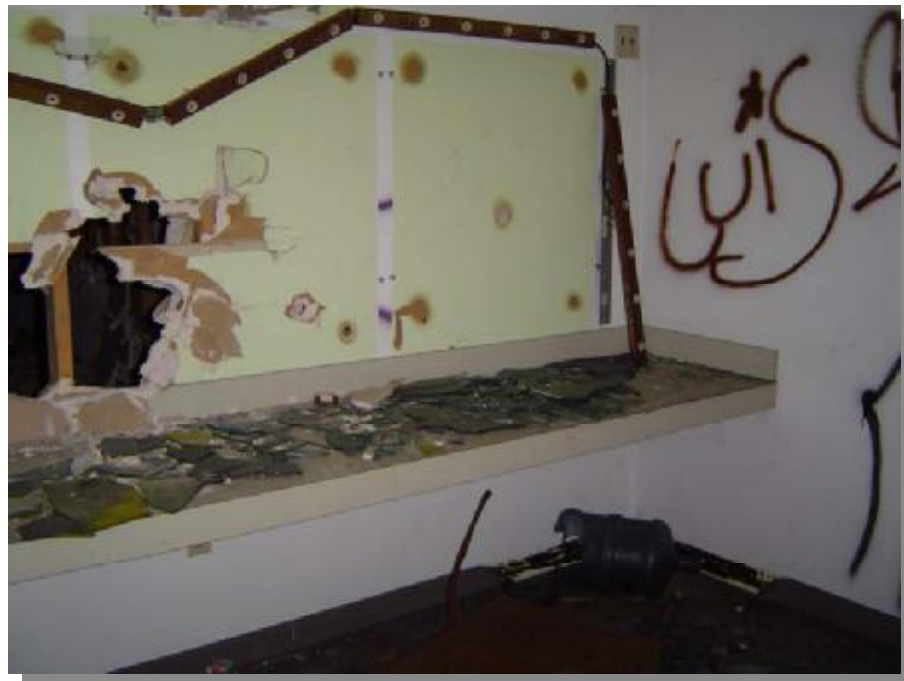
26- Dressing Room Area General Building Condition

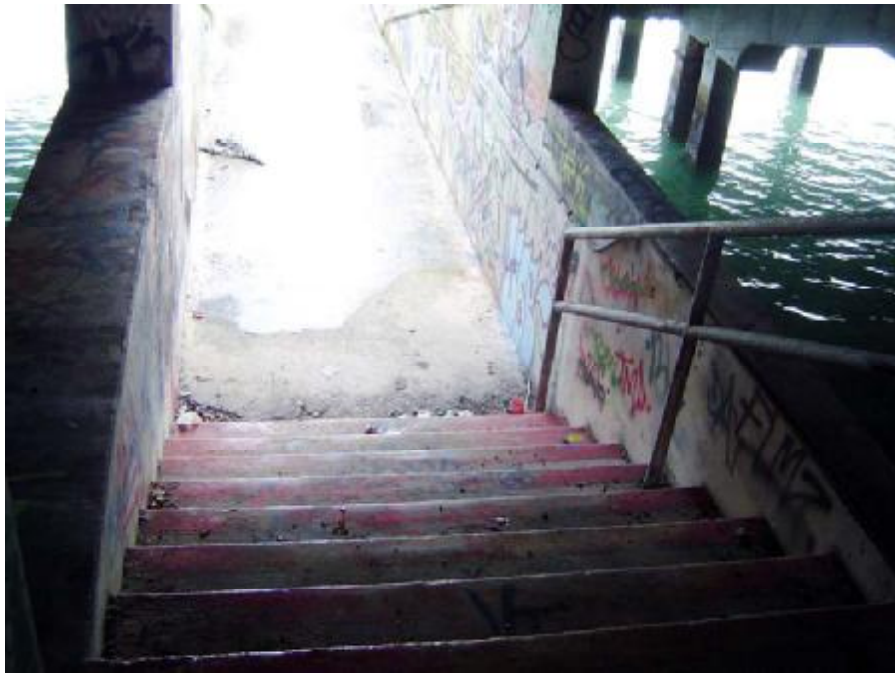
27- Lower Level Seating Access

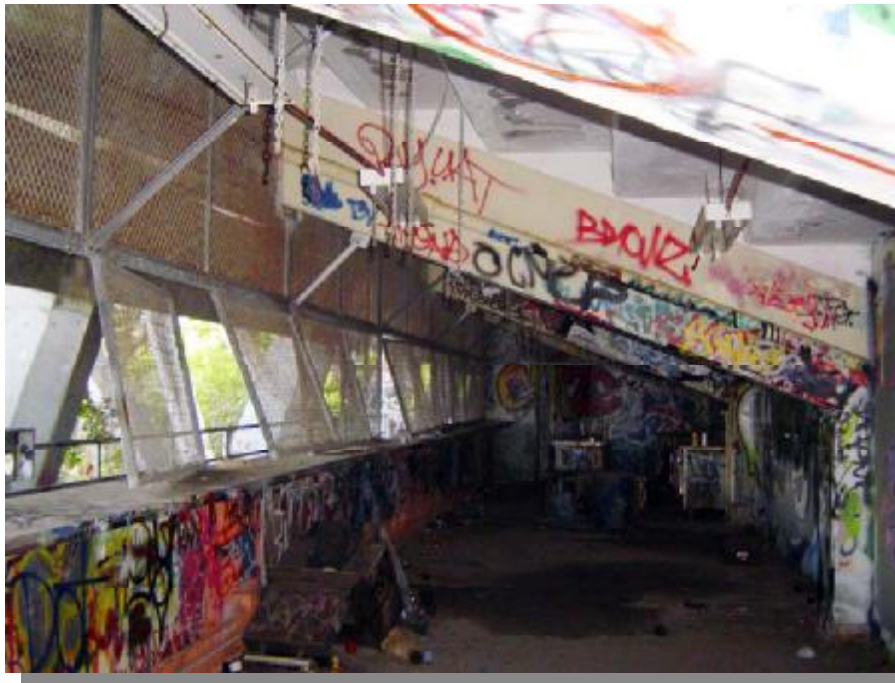
28- Concession Area

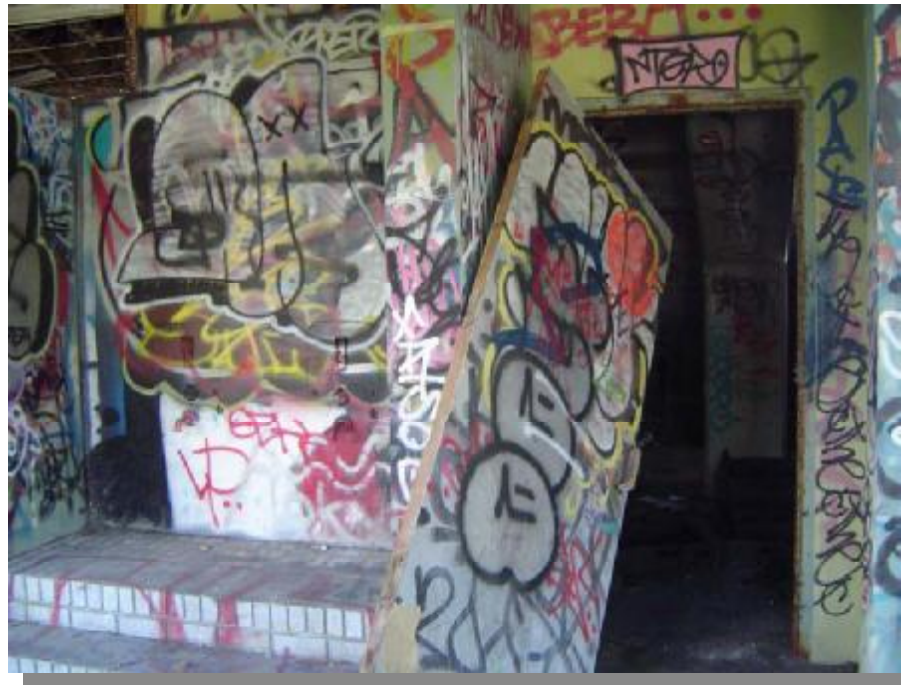
29- Water Fountain Area with No Handicap Accessibility

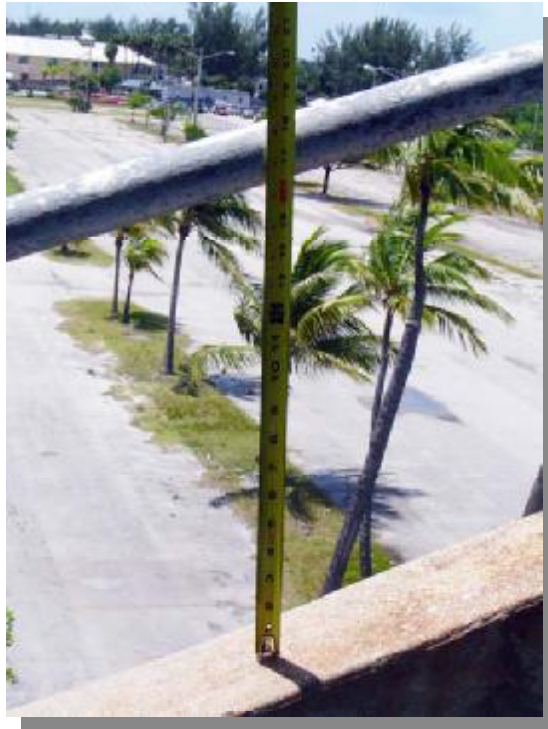
31- Railing Spacing at Grand Stand Seating Area

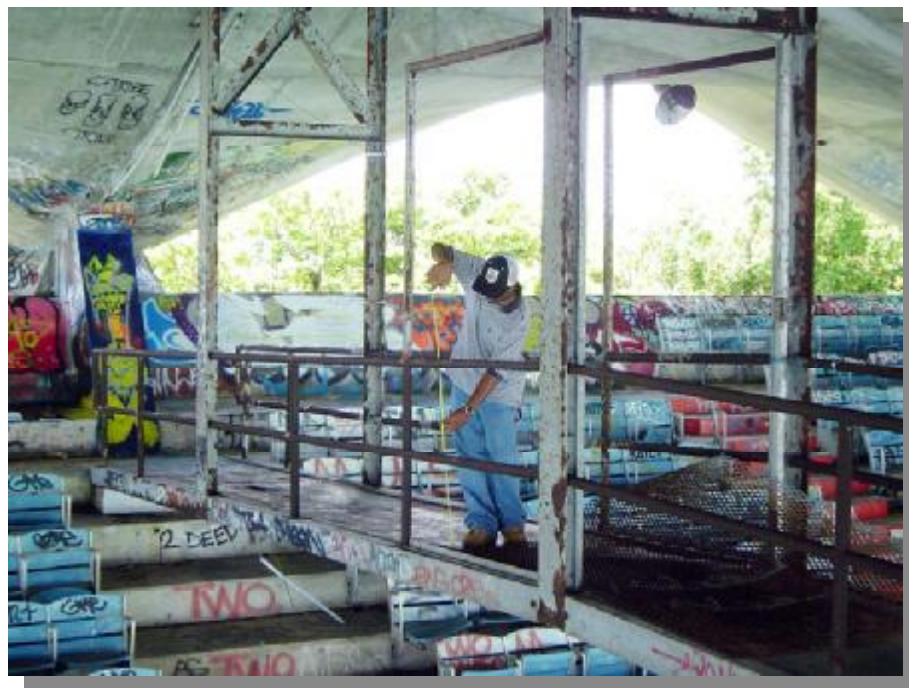
32- Access to Control Booth

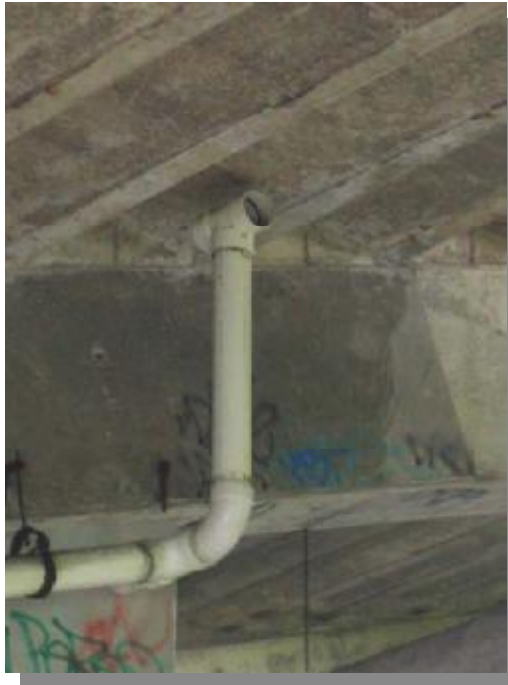
33- Sanitary System Vented Below Grand Stand Seating

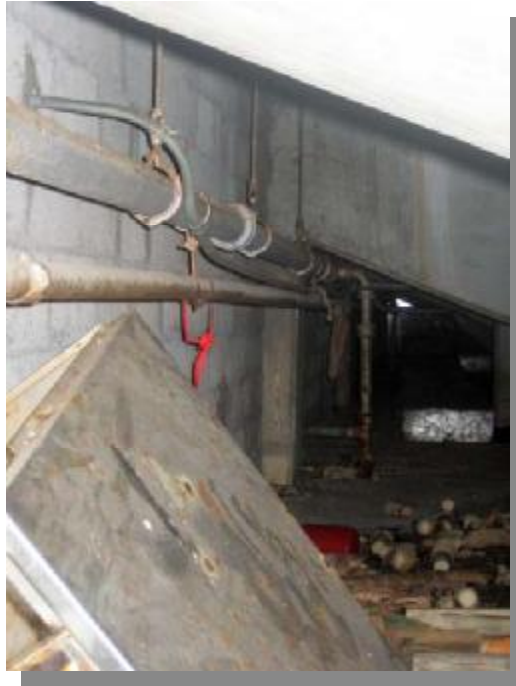
35- Air Handling Units in Crawl Space

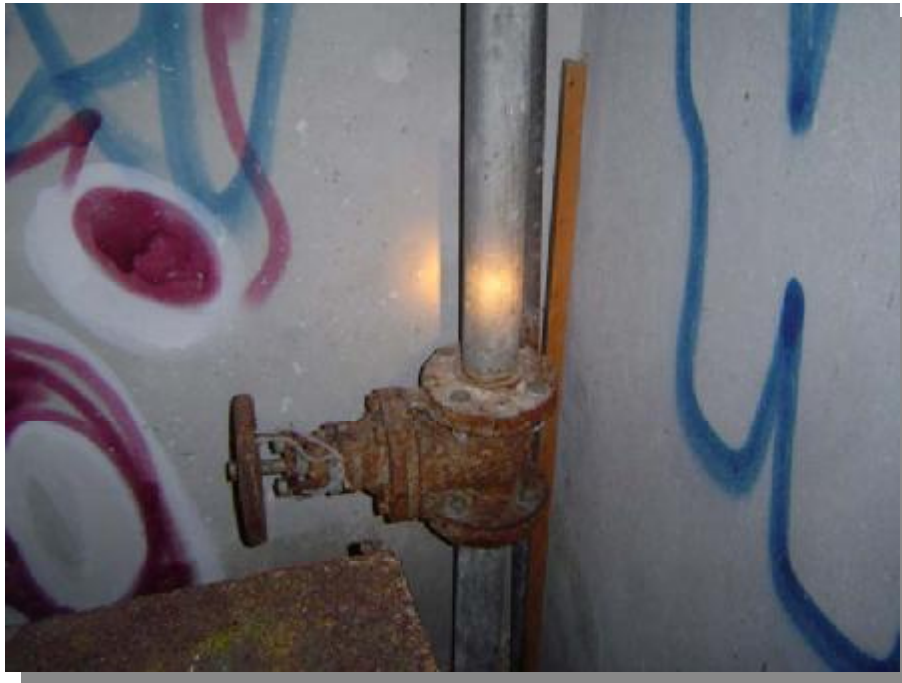
36- Fire Hose Riser

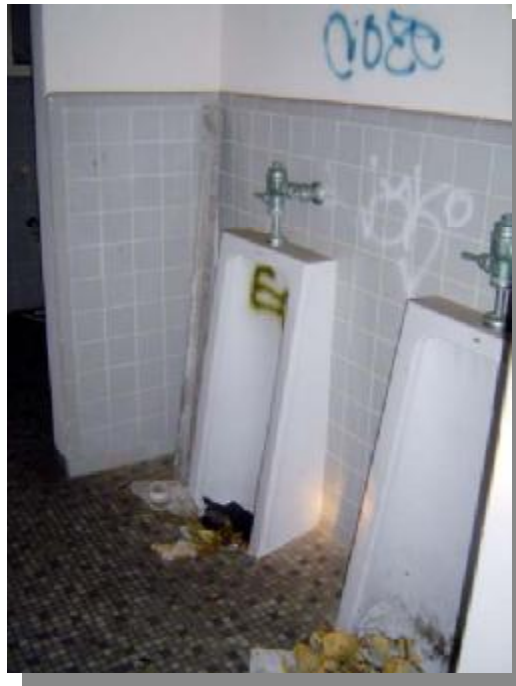
39- Plumbing Fixtures with Debris

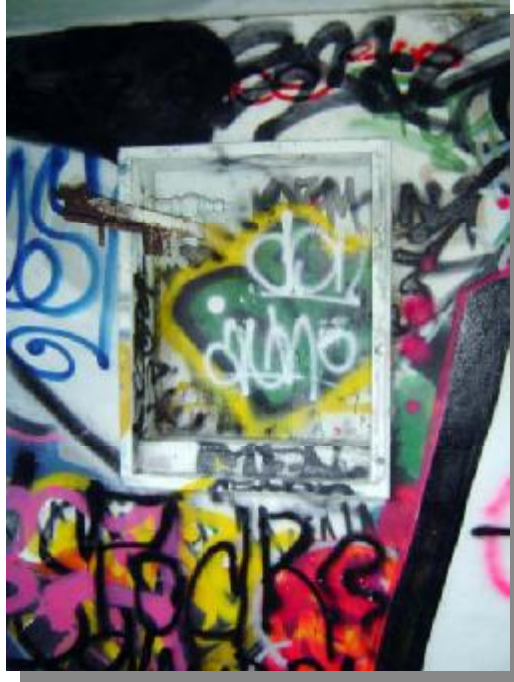
41- Disassembled Fire Hose Cabinet

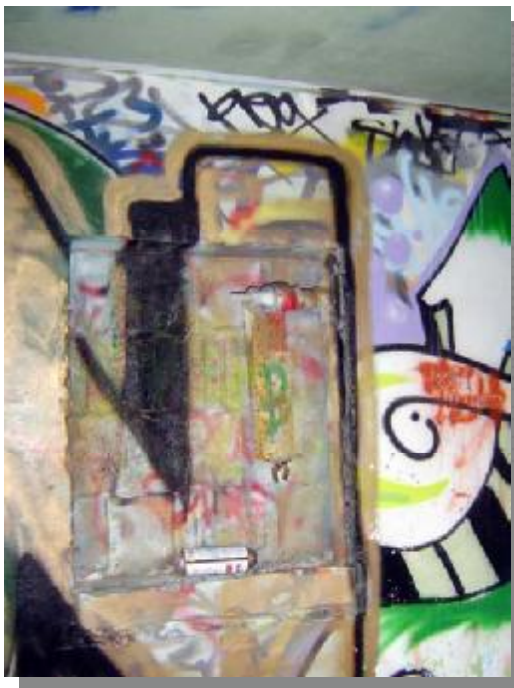
42- Disassembled Fire Hose Cabinet

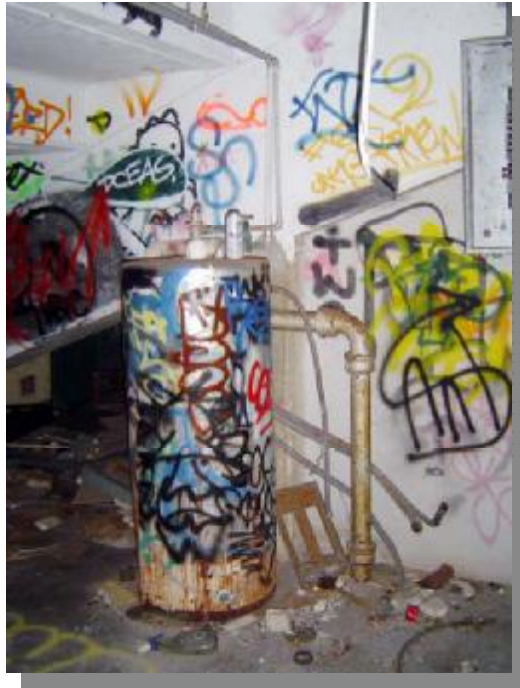
43- Water Heater and Cast Iron Piping

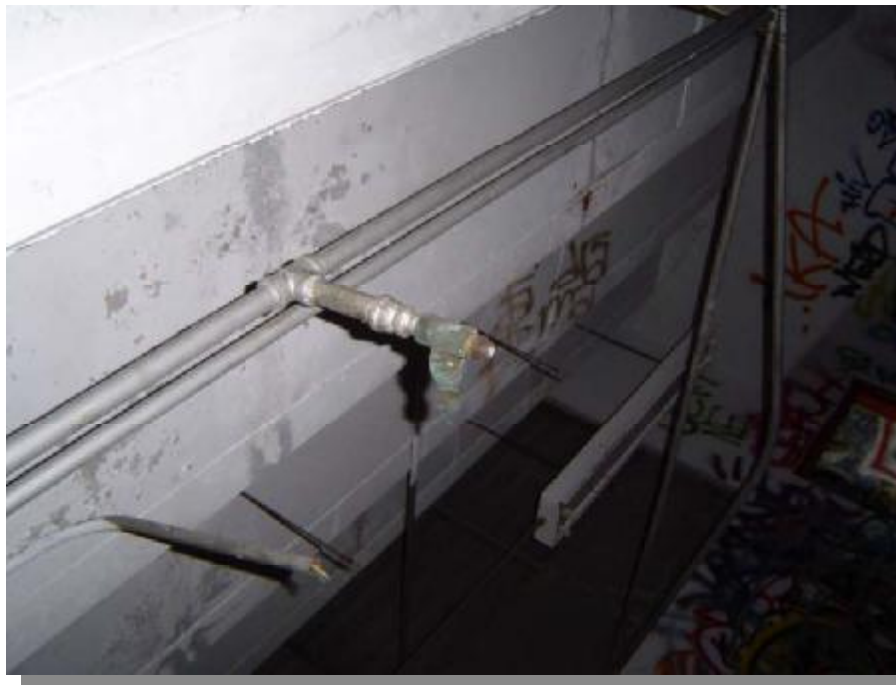
44- Potable Water Cold Supply

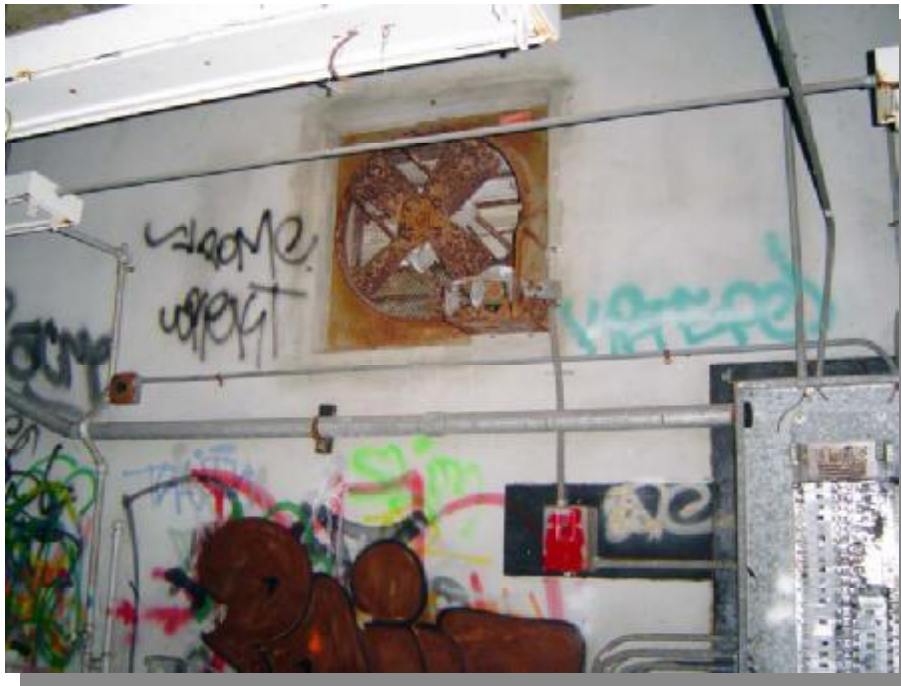
45- Exhaust Fan

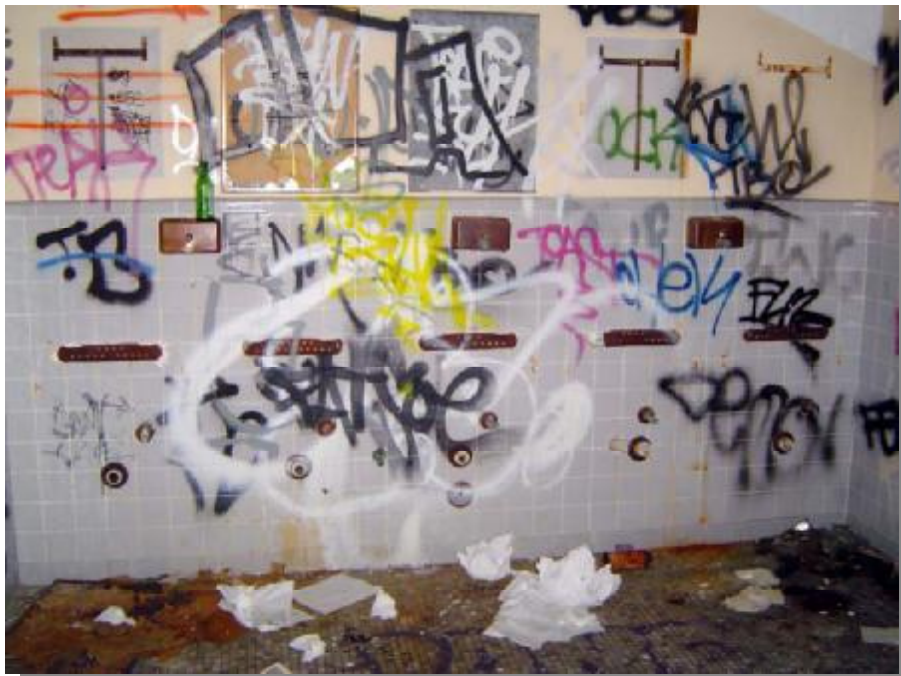
46- Restroom with All Fixtures Stolen

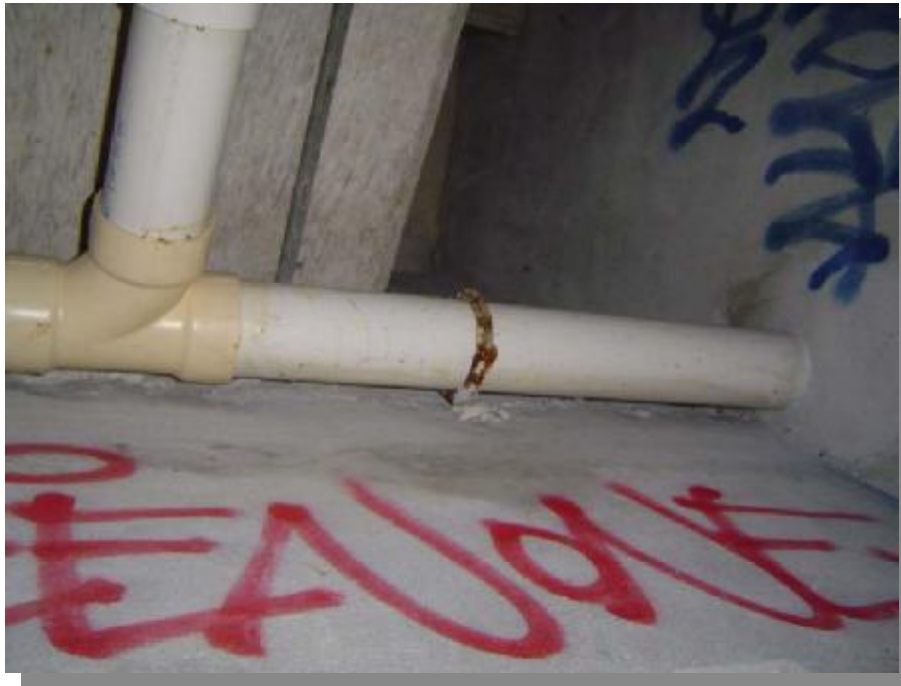
47- PVC Sanitary Pipe Retro Fit

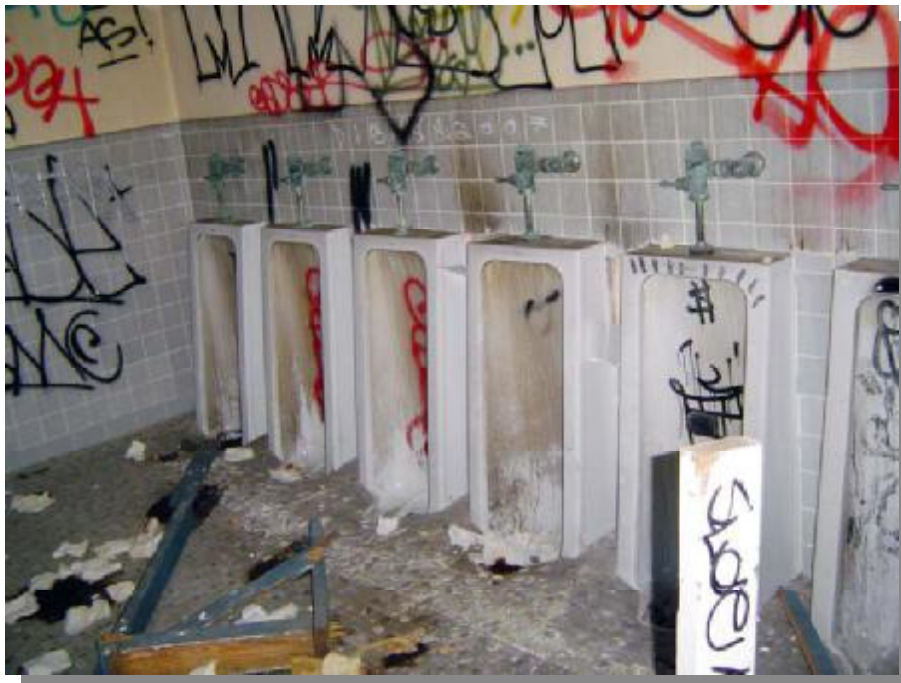
48- Plumbing Fixtures with Debris

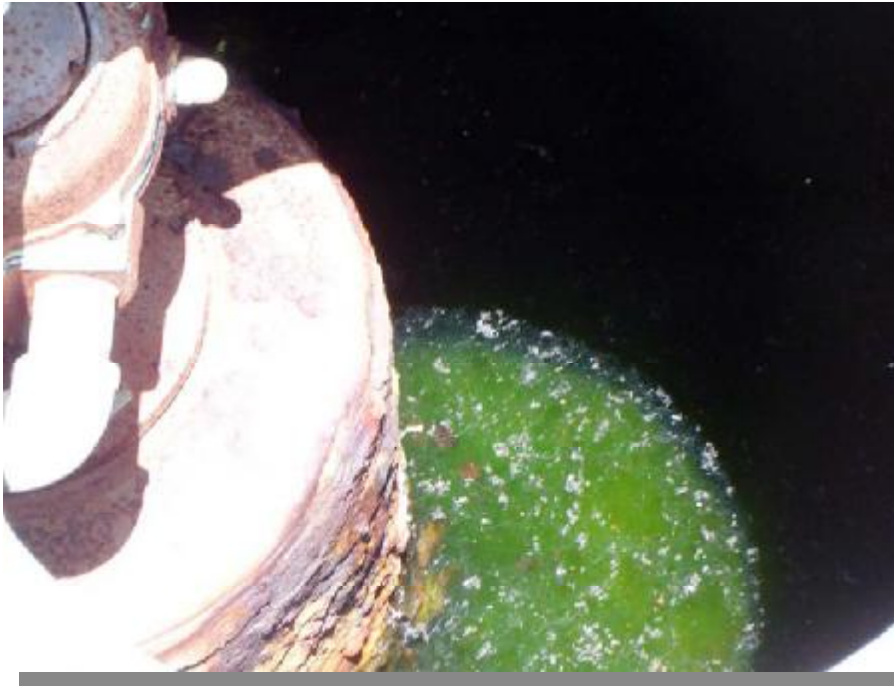
49- Lift Station

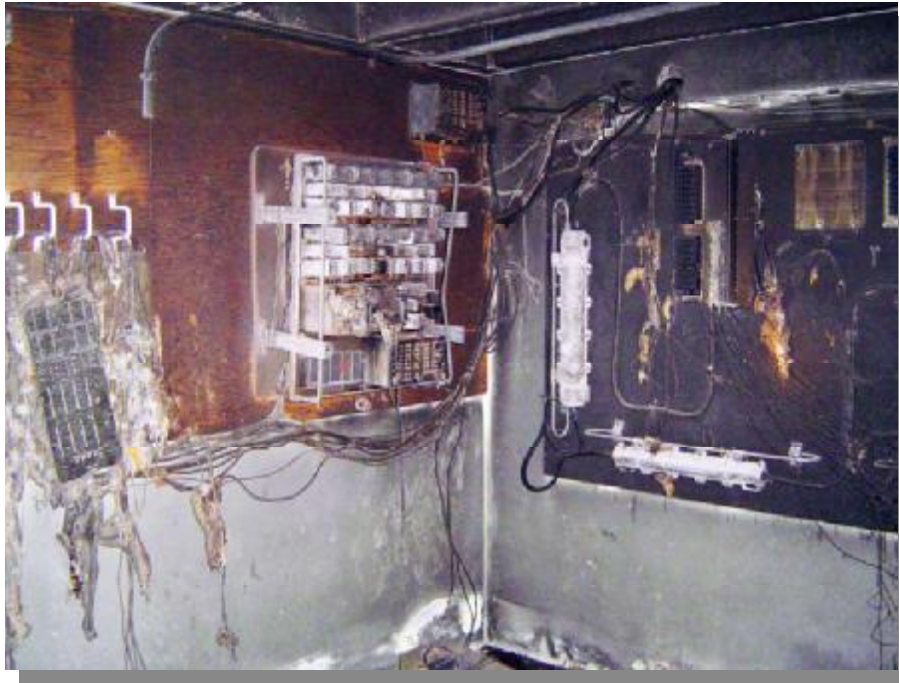
53- Phone System

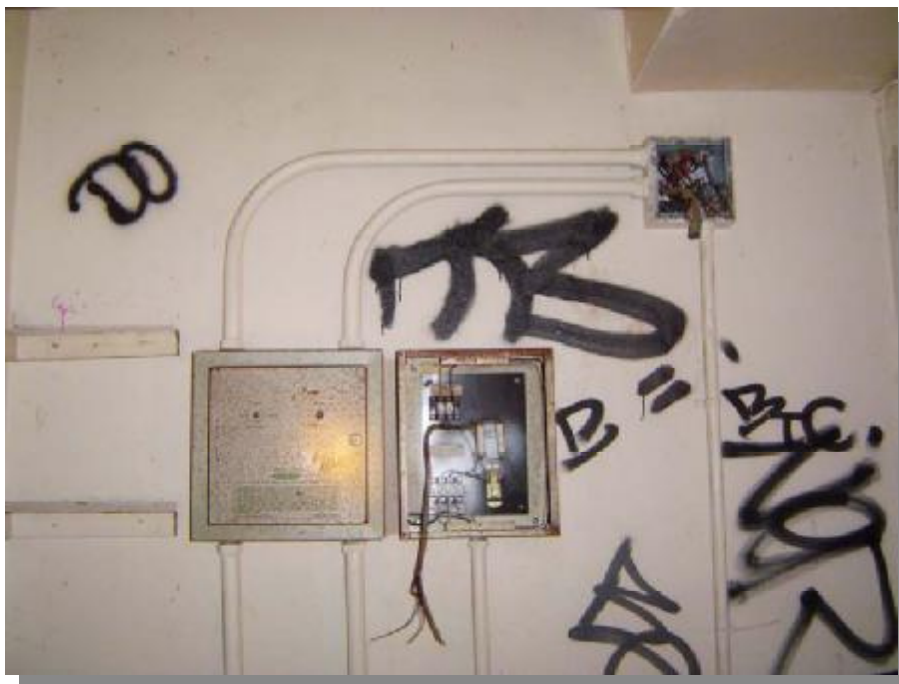
54- Open Junction Box and Disassembled Disconnect

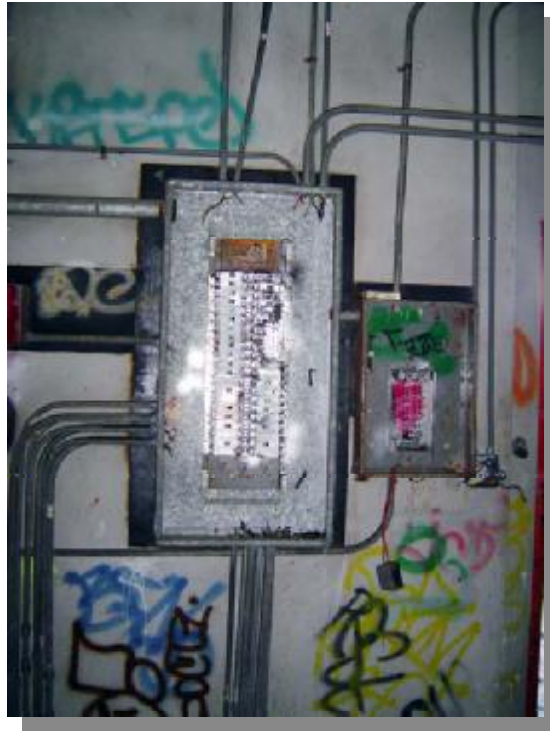
55- Disassembled Electrical Panel

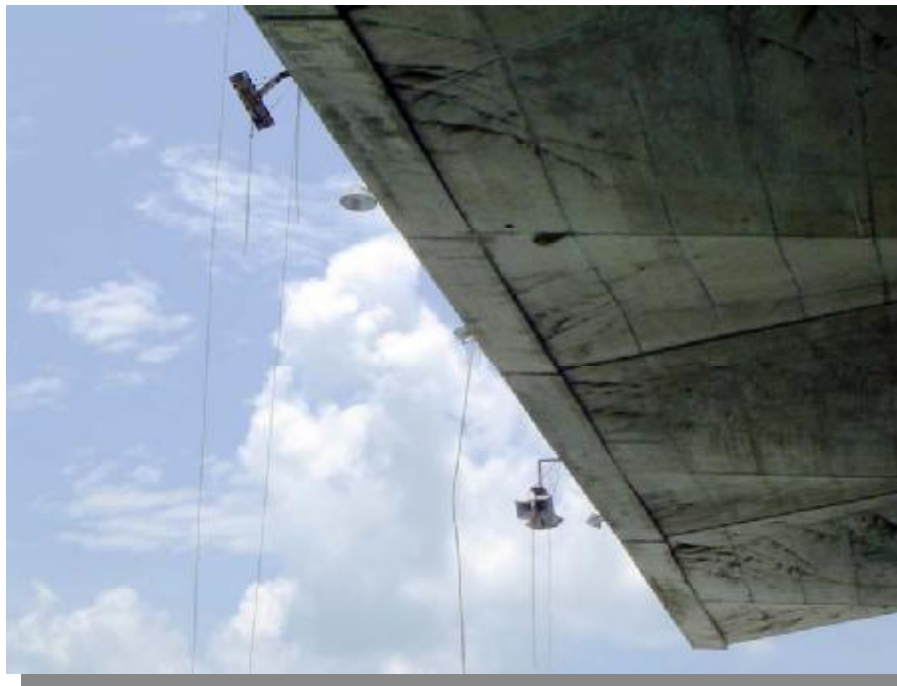
58- Lighting and Sound System Typical Condition

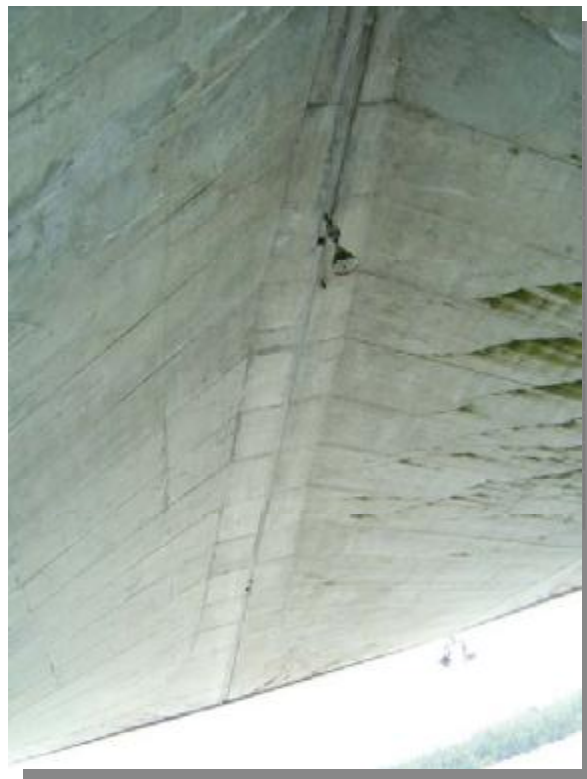
69- Over Head Canopy with Water Seepage

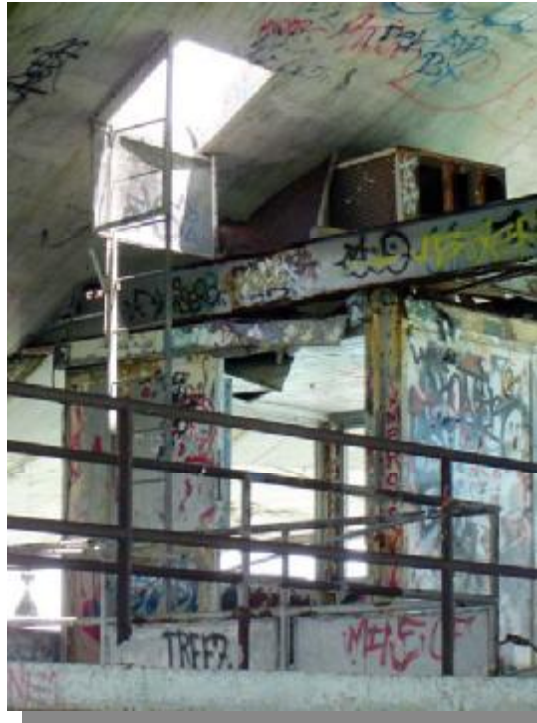
70- Over Head Control Booth with Steel Structural Beam Penetrating Concrete Structure

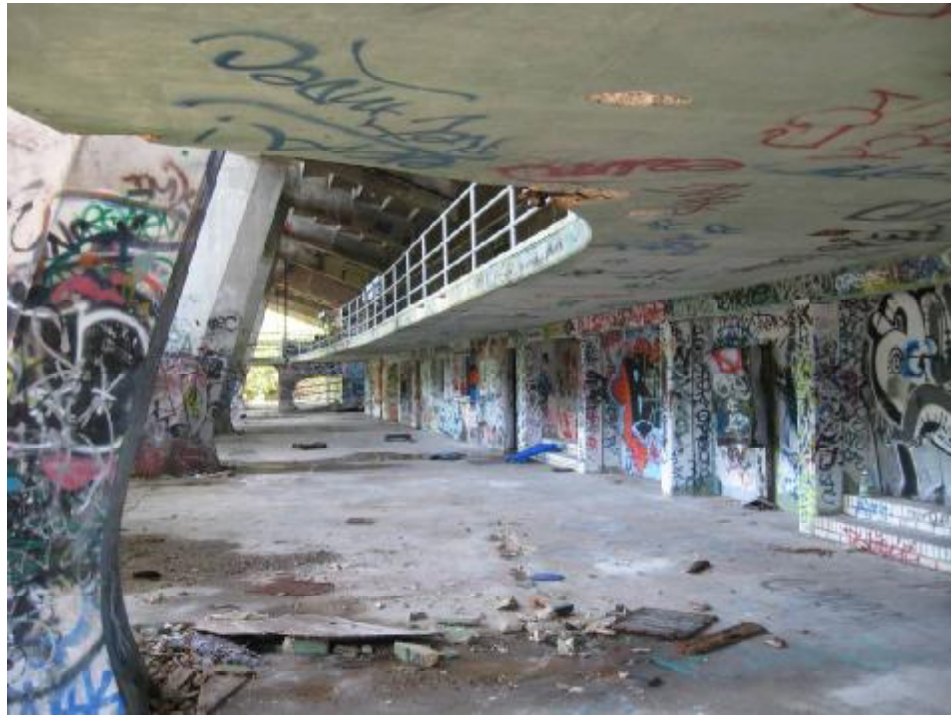
Photo 7

concrete and exposed corroded rebar (Photo 7, 8, 9, 10, 11, 12, 17). Each of the deteriorated areas requires repair to prevent further deterioration and to eliminate the many tripping hazards to the occupants.

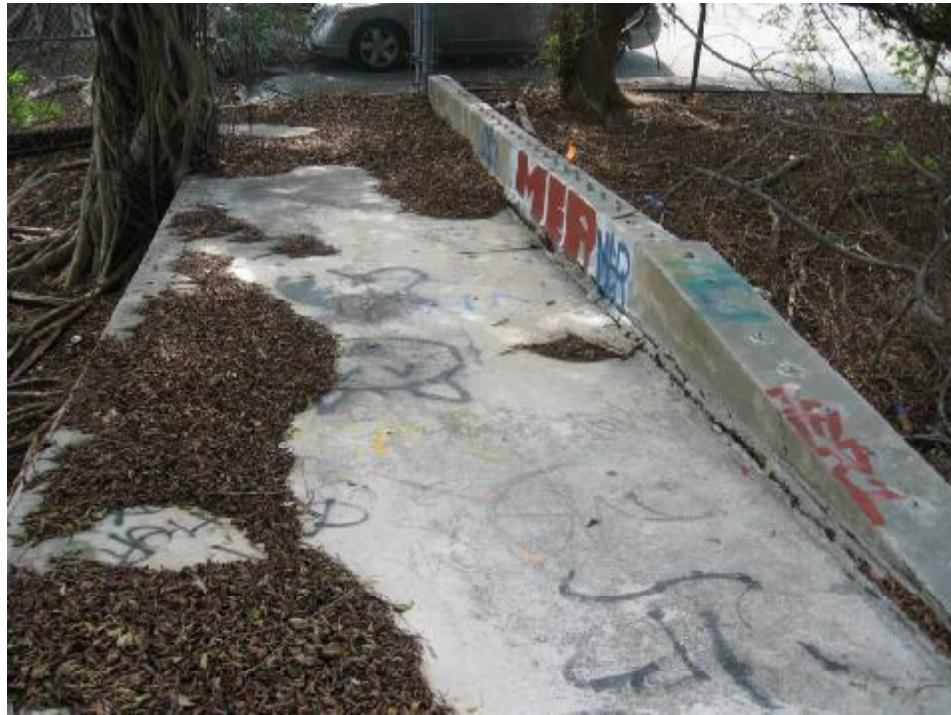
Photo 13

The ramp on the east side of the stadium is severely deteriorated and requires replacement (Photo 13, 14).

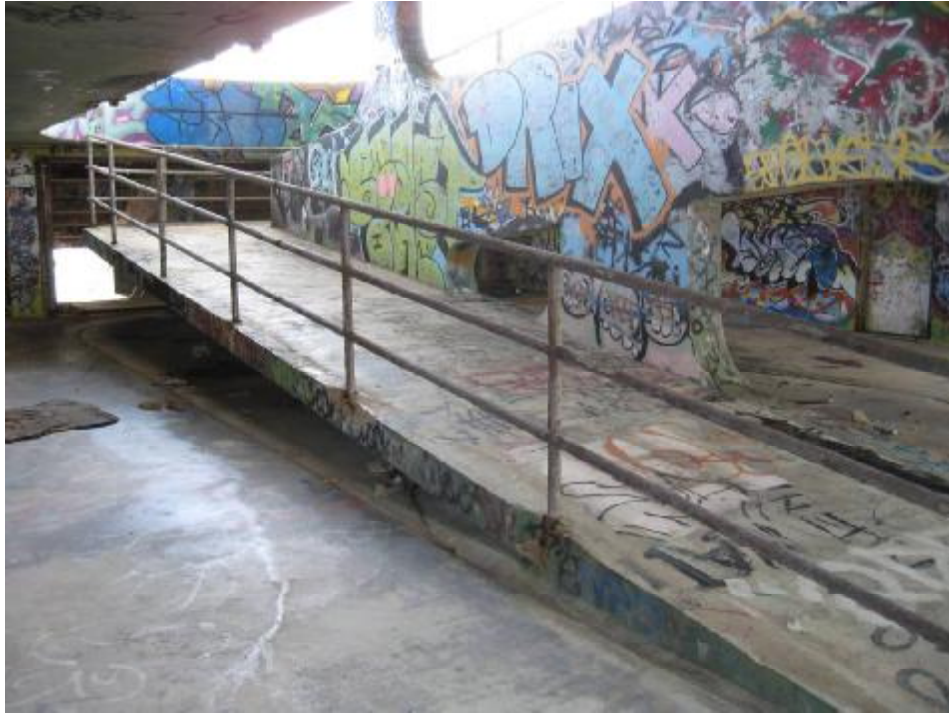
Photo 15

The ramps centered on grid lines 5 and 13 have mild deterioration, with areas of spalled concrete and exposed corroded rebar requiring repair (Photo 15, 16).
